Straw-bale Construction

by Bruce King, P.E.
Civil Engineer
Sausalito, California
www.ecobuildnetwork.org

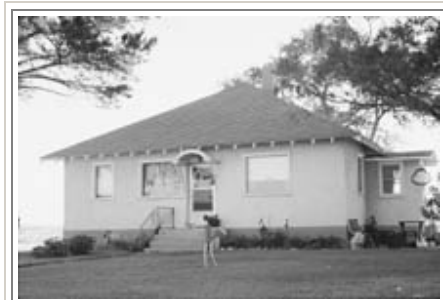
The Scott house was built outside of Gordon, Nebraska, in 1936. It is a classic "Nebraska style," or load-bearing straw-bale house, in that the bale walls carry the roof and lateral loads.

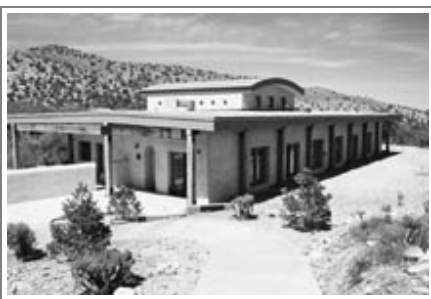
Large post-and-beam straw-bale house outside Moab, Utah. The nearly 100-year-old timbers used in this house were salvaged from a railroad trestle that once crossed the Great Salt Lake.

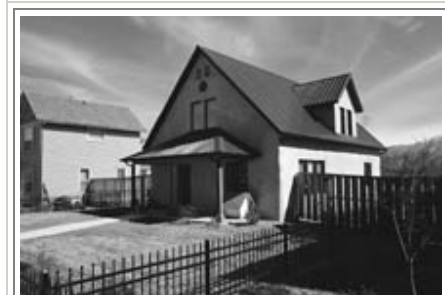
Post-and-beam straw-bale house built in Colorado Springs, Colorado. It is actually two stories in the back, because the lot slopes steeply.

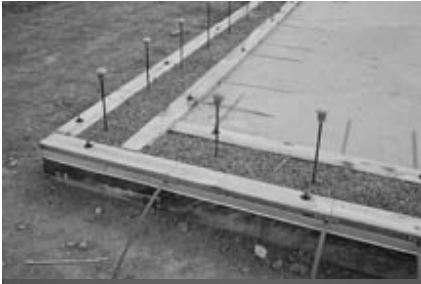
A typical foundation detail for a load-bearing straw-bale house on a concrete slab on grade. Bales will sit on treated wood sill plates bolted to the foundation, with pea gravel in between as a capillary break.

The bottom of the bale wall must be well separated from the foundation; at the very least, a waterproof barrier should be laid over a supporting concrete surface to halt any wicking moisture from below. Additionally, many builders are laying a 1-inch (25.4 mm) layer of pea gravel between 2-by-4 plates along the inside and outside faces, thereby ensuring that the bales will never be sitting in water.

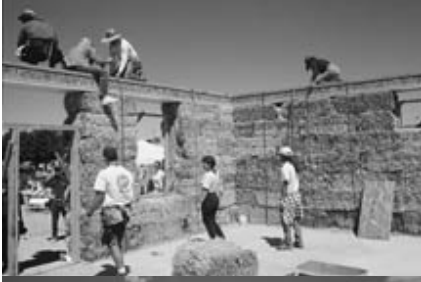
All the bales were stacked and the roof-bearing assemblies were in place and being strapped down by lunch time on the day of the wall-raising for this load-bearing straw-bale house built by the Town of Guadalupe, Arizona.

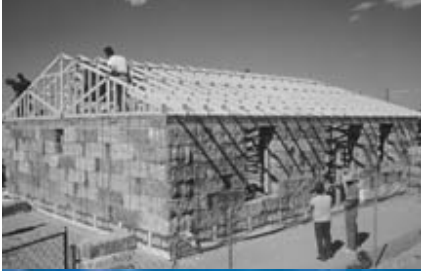
By midafternoon, all the trusses were in place. By the end of the day of the wall raising, the roof was sheathed and ready to be dried in

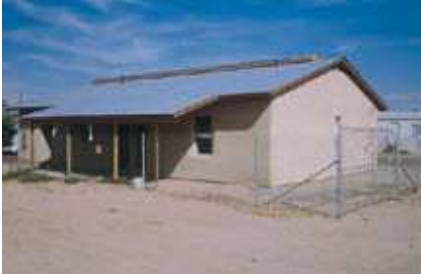
The finished house in Guadalupe, with a typical three-coat stucco finish. It cost less than \$50,000 and is a very energy-efficient, 1,120-square-foot (104 m²), three-bedroom dwelling.
